## SBAR – Aesculap Tamper Evident Lock US910

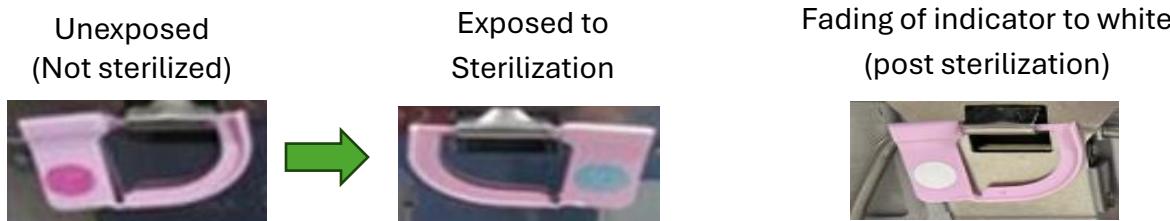
The Aesculap tamper evident lock- (US910) is used as the external process indicator lock for Aesculap brand containers. These locks are used as a visual indicator to identify that the instrument tray has gone through the low temperature sterilization process.

These process indicator locks have a color change from Magenta to Blue once exposed to the appropriate sterilization modality.

With review of the MIFU, it has been identified that these indicators may turn white post-sterilization due to uncontrolled temperatures or exposure to direct light.

However, after reviewing the storage location of these instruments and proximity to the overhead lighting, it was determined that lighting was a contributor to the fading of the indicator lock. With the lighting being the contributor of the color change, and reviewing with infection prevention to assess the risk, it was determined the white color change does not pose a sterilization risk to the instrument tray or patient.

Expected practice: If you find the Aesculap lock (US0910) with a white indicator, just like with other sterile instrument trays, make sure to check that all sterility quality checks are done. These checks include looking at the instrument tray package for any damage, checking if the external locks are secure, ensuring the filters are in the right place, and confirming the internal chemical indicator is within the acceptable color range. Once all these sterility quality checks are passed, it is safe to use the sterile instrument tray.
